# Database Verification for Water Lines Assessment in Banyan Village, Port LaBelle

**March 16, 2010**

Estelle Gagnaire, M.E.  
Margherita Fanchiotti  
*Intelligentsia International, Inc.*

John Capece, Ph.D.  
*Southern DataStream, Inc.*

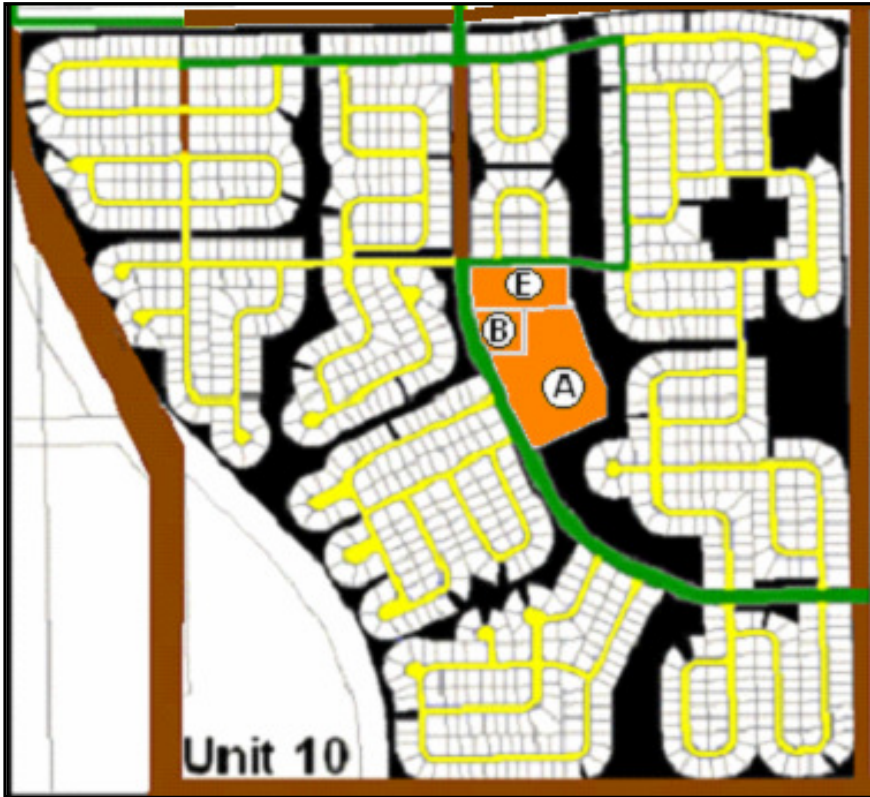
Figure 3. Unit 10 with a color key representing lots and pipes.

Figures 3 through 8 provide map descriptions of all the Banyan Village lots and roads relative to their access to road frontage and water lines. The following color codes apply to Figures 3 through 8:

- black: water management lots
- green: streets with main water pipe of 8 to 16-inch diameter
- yellow: streets with small water pipe of 6-inch diameter
- brown: streets with no water pipes
- red: streets not constructed and no water pipes
- grey: residential lots with access to water lines
- pink: residential lots without water pipe frontage
- orange: education (E), business (B) and government (G) parcels

Four of the ten non-residential parcels do not have access to potable water lines. They are identified in Figure 3 - 6 and Table 6 - 8.

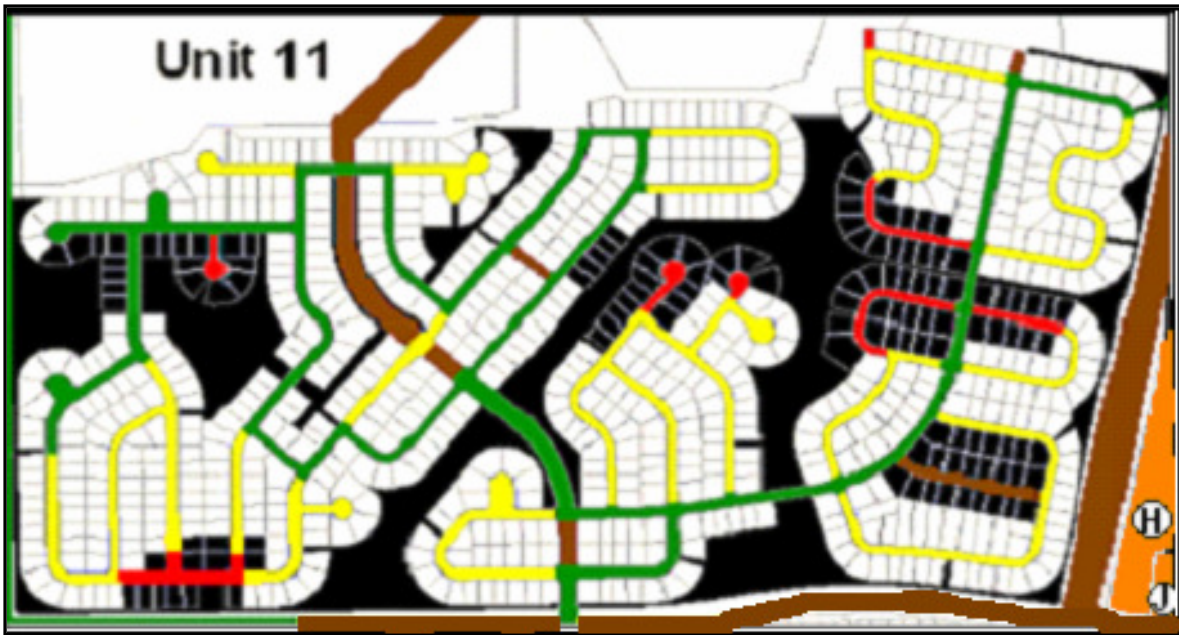
Figure 4. Unit 11 with a color key representing lots and pipes.

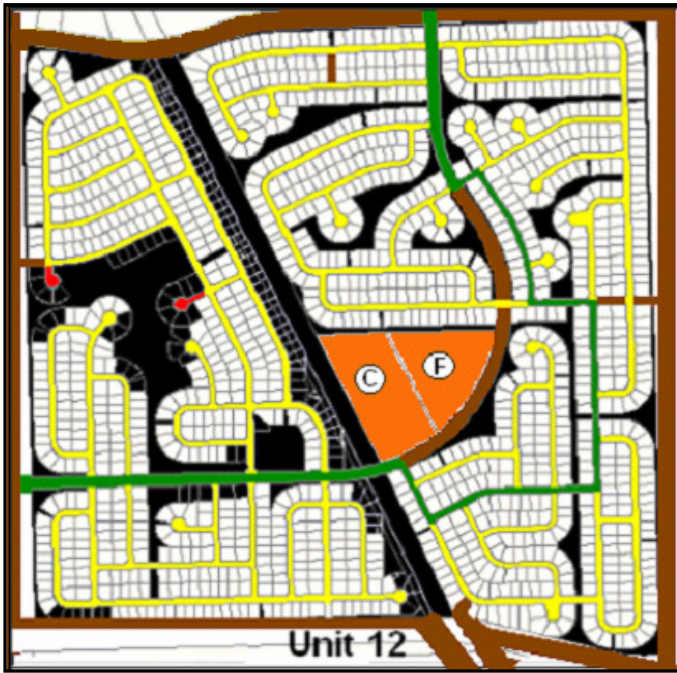
Figure 5. Unit 12 with a color key representing lots and pipes.
